## 10. Conclusions

## 10.1 Flood Hazards

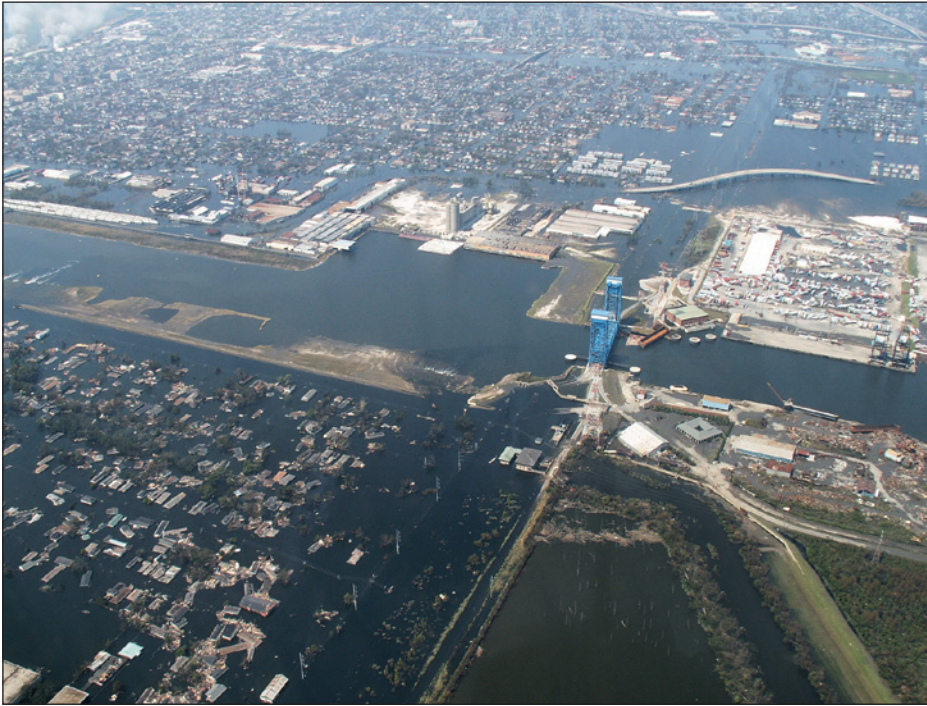
**Figure 10-1.**  
Levee failures resulted in widespread flooding throughout the New Orleans area.

2. BFEs in the levee-protected areas of New Orleans were based on the assumption that the levees and floodwalls would protect the surrounded buildings. When developing BFEs, current NFIP standards require that a levee be certified that it has been adequately designed and constructed to provide protection against the base flood. Since the levees protecting New Orleans are USACE-certified, the BFEs for the levee-protected areas of the City (which are currently mapped with BFEs as low as -4.5 feet NGVD) only reflect flooding from precipitation that falls on and accumulates inside these areas; the BFEs do not include flooding effects from waterbodies on the non-protected side of the levee, such as Lake Pontchartrain. When levees and flood walls were overtopped or failed in Katrina's storm surge, deep water flooding was widespread behind the levees (see Figure 10-1).

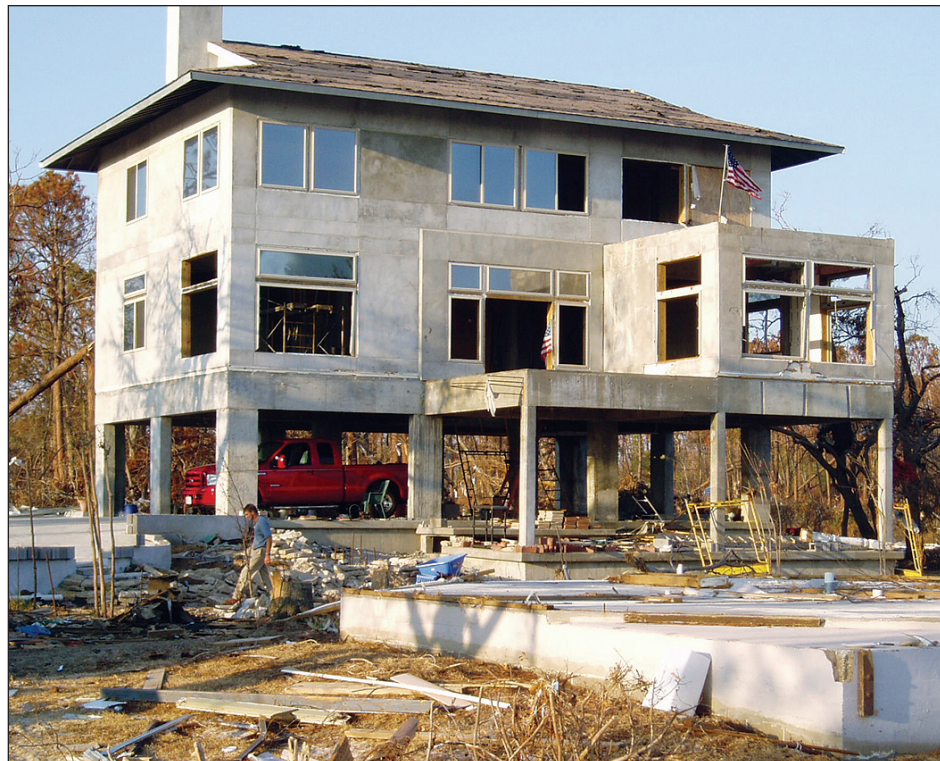
**Figure 10-2.**  
Elevation of the lowest floor well above the BFE as indicated by the slab in the foreground (Pass Christian, Mississippi)

Many of the damaged buildings were pre-FIRM construction and built on slab foundations that do not satisfy current NFIP requirements. Structures next to each other in impacted neighborhoods had varied elevations and buildings that were constructed to the BFE or below (for the pre-FIRM buildings) experienced greater impacts from flood levels, damaging waves, and floodborne debris than those structures situated well above the BFE (see Figure 10-2).

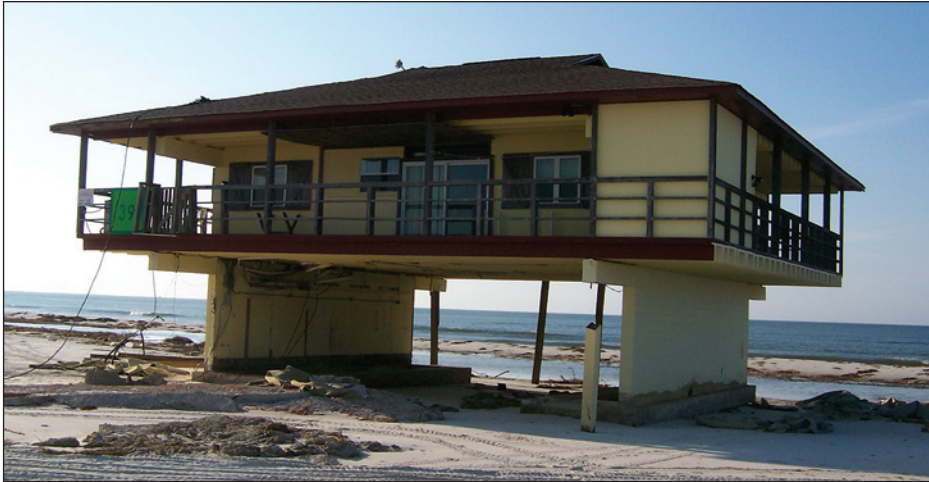
Figure 10-3.  
Home constructed  
on solid, shore-  
perpendicular foundation  
walls. The walls are  
supported by reinforced  
concrete beams placed  
on driven piles (Dauphin  
Island, Alabama).

Current NFIP regulations require elevation of V Zone buildings on pilings and columns (i.e., foundations). However, the NFIP has allowed some V Zone buildings, particularly mid- and high-rise buildings, to be constructed using some solid foundation walls beneath the BFE. These walls, called shear walls, are necessary to transfer large lateral loads (e.g., wind and seismic loads) from the upper stories into the ground. Use of properly constructed, shore-perpendicular shear walls in these large V Zone buildings has not been observed by the MAT to lead to building damage or failure during coastal flood events. Some one- and two-family residential buildings require elevation above the ground in excess of one story. For these residential buildings, the technical, policy, and financial implications of using shore-perpendicular foundation walls, such as the shear walls used by mid- and high-rise buildings, should be considered. The use of any solid foundation walls beneath a V Zone building will complicate the flood insurance rating process and may lead to substantially higher flood insurance premiums than those for a building supported entirely on piles or columns (see Figure 10-3).

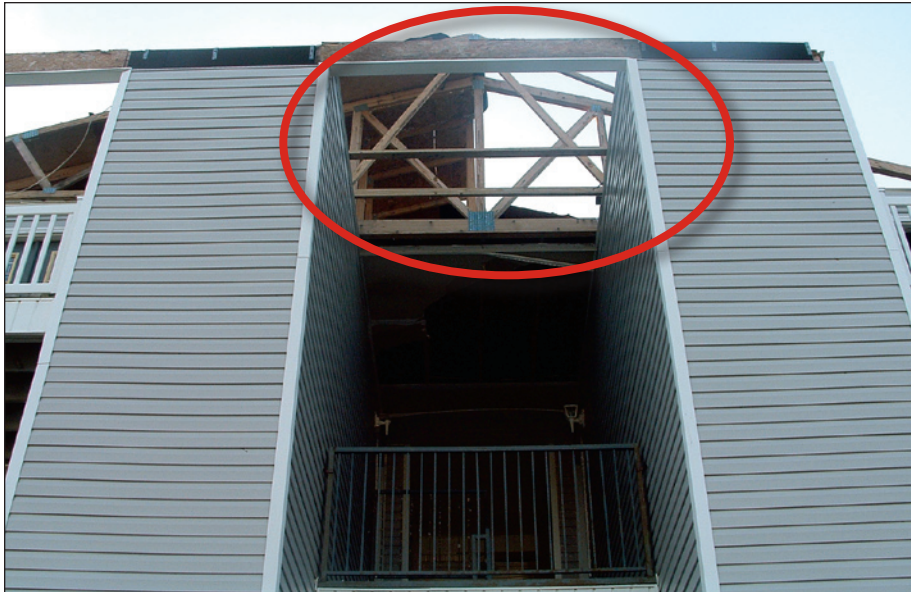
Figure 10-4.  
Classic soffit failure  
resulting in attic  
pressurization and roof  
decking failure. The  
stairwell soffit (circled)  
was blown away during  
the storm (Long Beach,  
Mississippi).

Soffit failures in residential buildings often led to internal pressurization of attics and loss of inadequately attached roof decking (see Figures 10-4 and 10-5).

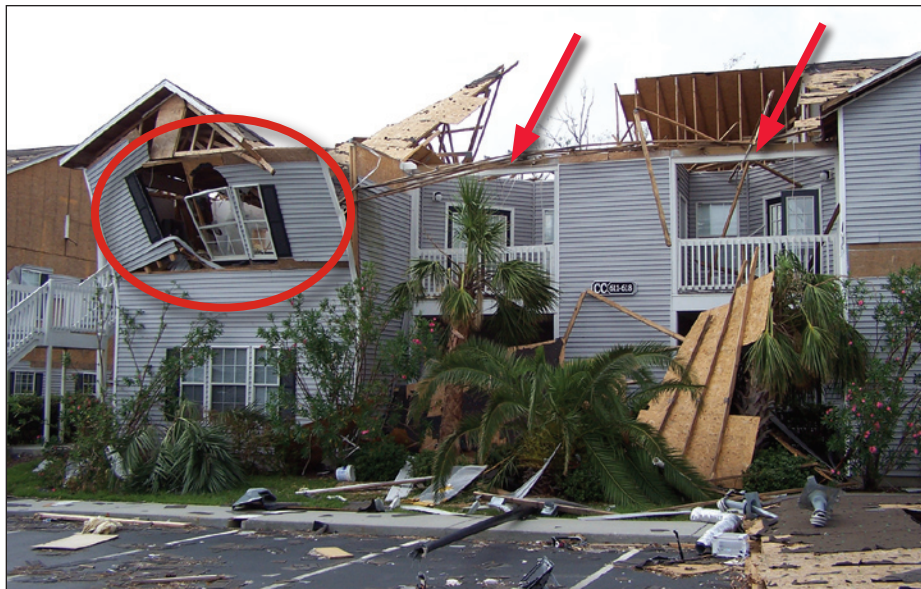
Figure 10-5.

The failure of this apartment building was the result of inadequate connections and interior pressurization caused by broken windows and failure of the porch ceiling. Note the broken glazing (circle) and the failed porch ceilings (arrows) (Ocean Springs, Mississippi)
